Wire Rope Breakage on Centipede Activity

On 24/6/19 at 4:40pm, it was brought to the attention of Project Adventure Australia (PAA), that a wire rope (cable) which was the primary attachment for a Centipede activity, broke, resulting in the Centipede falling to the ground.

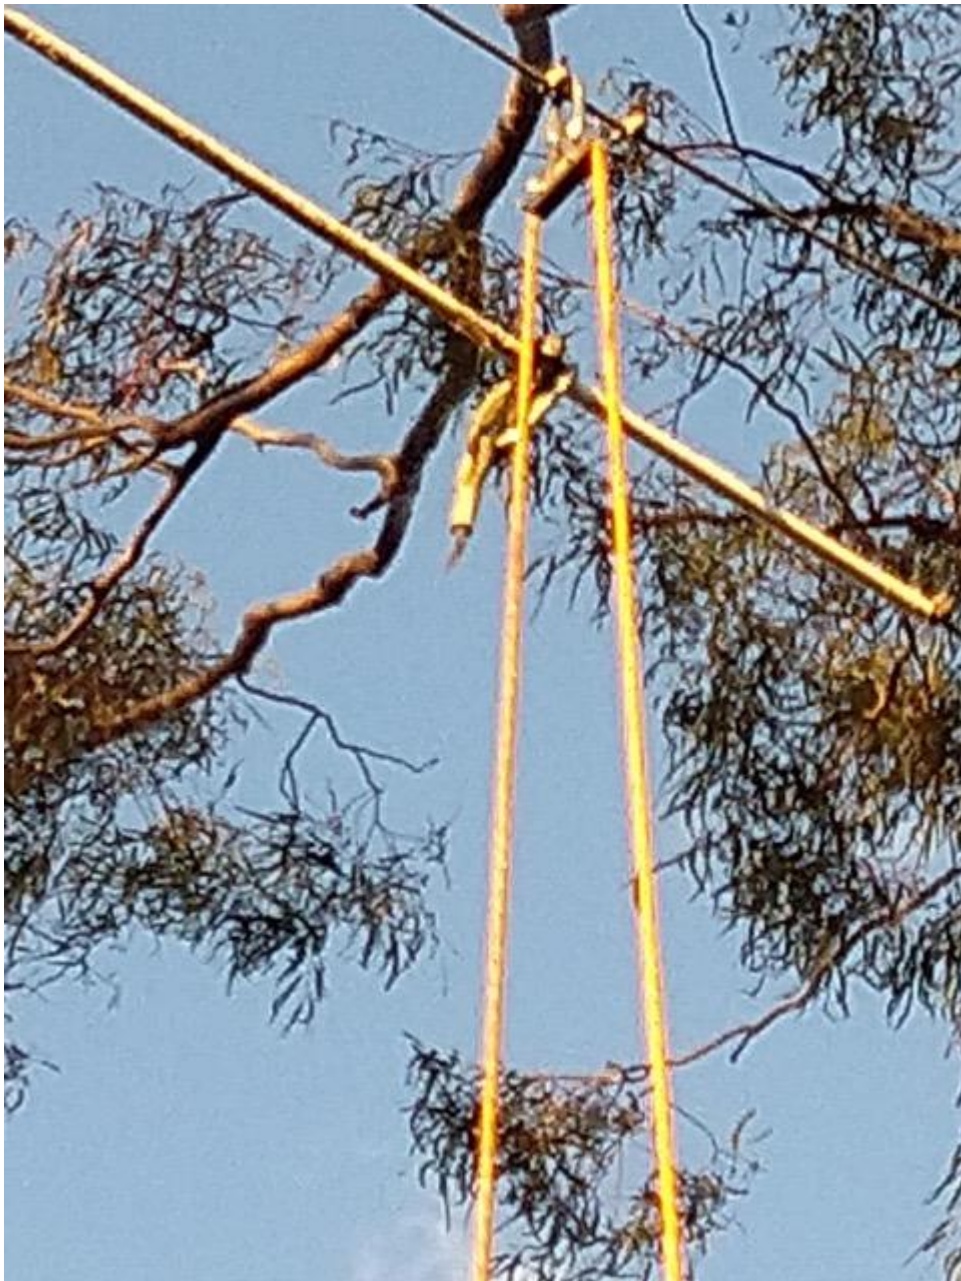
The Centipede is a series of logs that are attached to each other, end to end, and hung vertically. Starting at ground level, participants ascend the logs via staples or climbing holds to see how high they can climb.

suspended from a horizontal support cable with a belay cable located approximately 80cm above the activity. Modifications to the Centipedes primary attachment points were carried out in 2013.

1. Visually inspect the cable that attaches the Centipede to the horizontal support cable, or in some instances an eye bolt. Pay particular attention to the cable between the 2 swages, as indicated by the arrow in the drawing below.

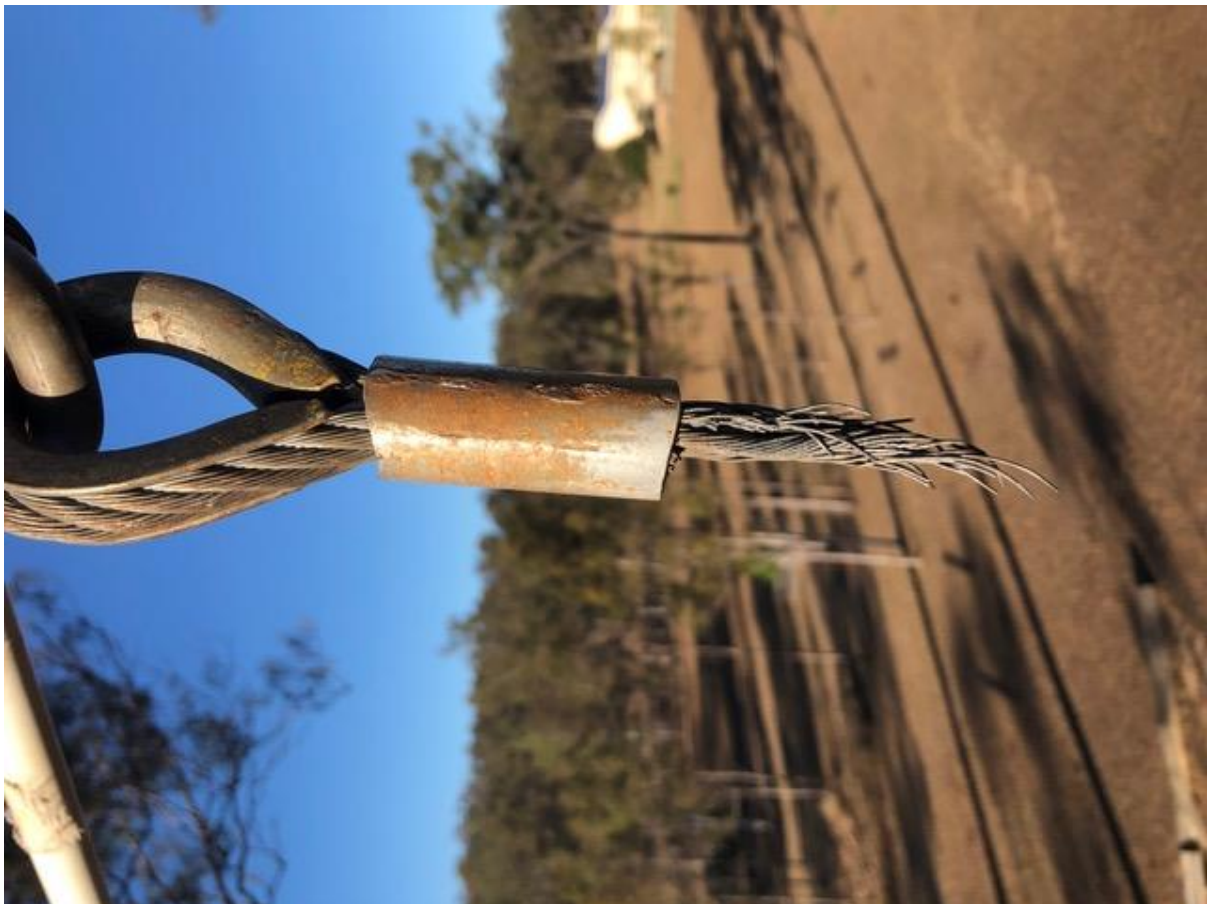
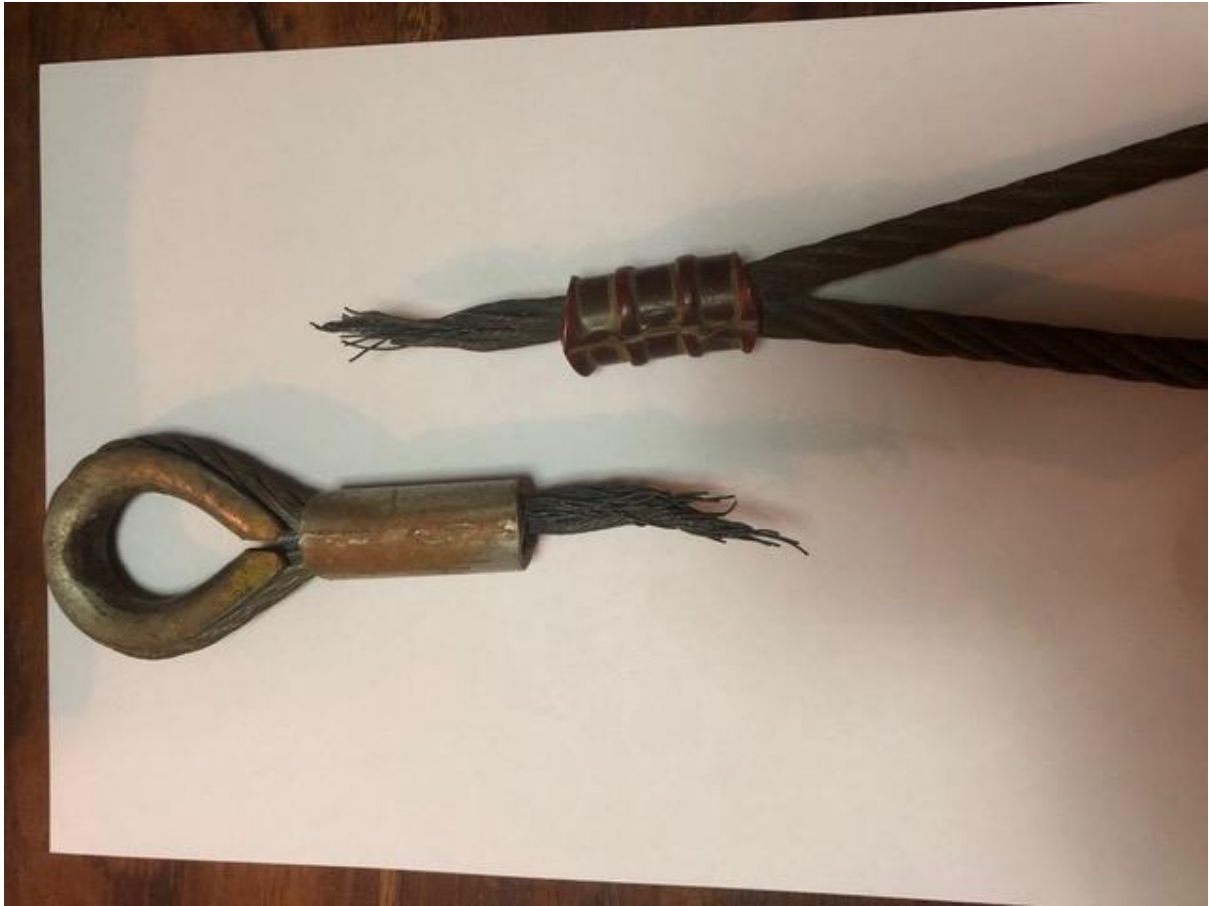
At some point, prior to the failure of the wire rope, the Centipede was twisted/wound many times from the ground in order to create a spinning motion of the Centipede when it was let go. This twisting/winding motion caused the strands of the attachment cable at the top of the centipede to twist open. This resulted in individual wires bending and subsequently breaking. Owing to the length of the Centipede, the leverage and torque achieved led to many of the individual wires and strands breaking.

The Centipede continued to be used as the damage caused by misuse was undetected by centre staff since the attachment point is difficult to see from ground level. The usual movement of the activity caused the remaining wires to break and the Centipede to fall.

Photos from broken centipede.

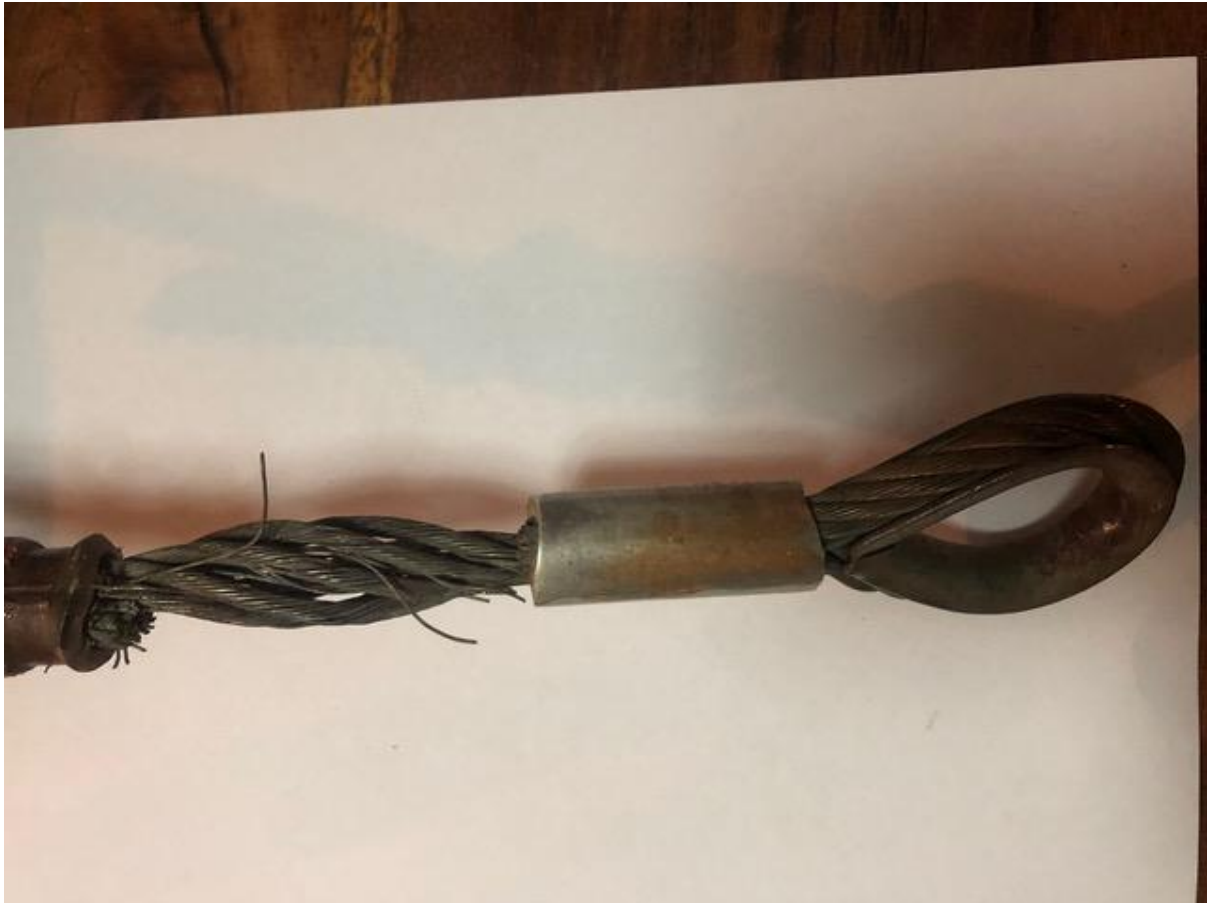
When I inspected the second centipede on the same day, it showed the initial signs of similar misuse with a few broken wires evident from similar winding/twisting. I went on to twist the Centipede another 3 times, noting that wires continued to break as I twisted.

This photo is the attachment point of the second centipede.
