Wire Rope Breakage on Centipede Activity

On 24/6/19 at 4:40pm, it was brought to the attention of Project Adventure Australia (PAA), that a wire rope (cable) which was the primary attachment for a Centipede activity, broke, resulting in the Centipede falling to the ground.

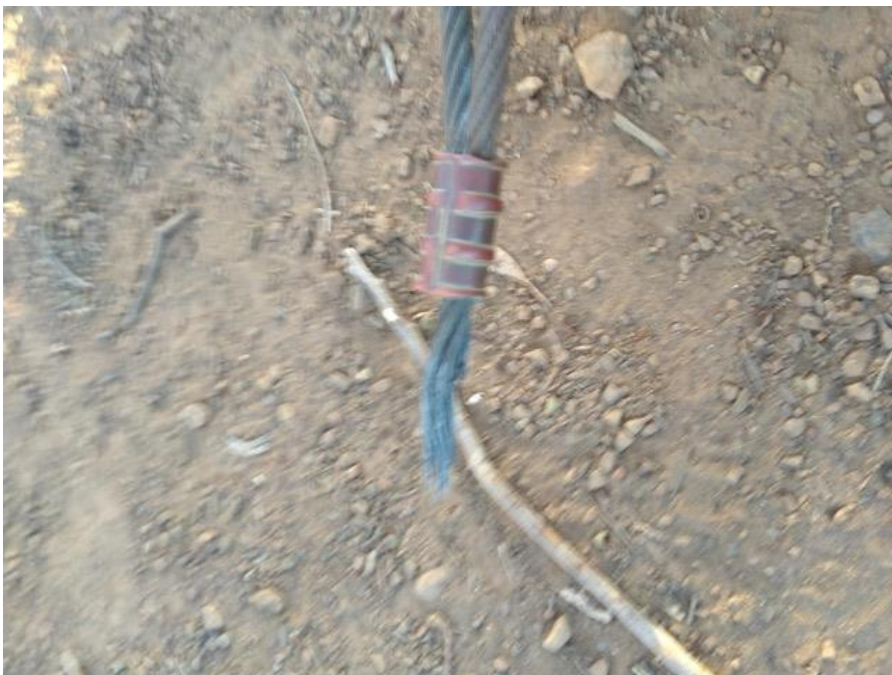
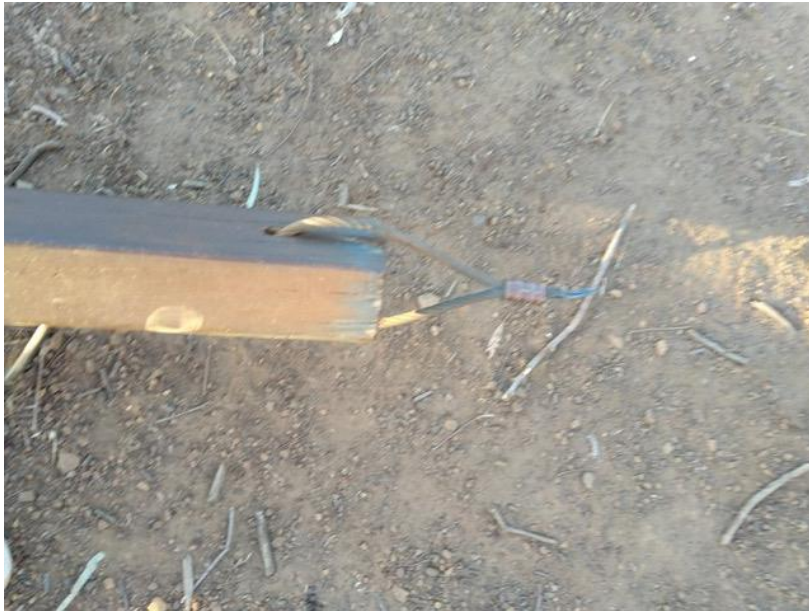
On 24/6/19 at 4.30pm, the activity was being climbed by a year 6 male when the Centipede attachment cable failed. The participant was being dynamically belayed at the time and was immediately lowered to the ground.

The determined reason for the failure of this wire rope was - misuse of the activity.

At some point, prior to the failure of the wire rope, the Centipede was twisted/wound many times from the ground in order to create a spinning motion of the Centipede when it was let go. This twisting/winding motion caused the strands of the attachment cable at the top of the centipede to twist open. This resulted in individual wires bending and subsequently breaking. Owing to the length of the Centipede, the leverage and torque achieved led to many of the individual wires and strands breaking.

The Centipede continued to be used as the damage caused by misuse was undetected by centre staff since the attachment point is difficult to see from ground level. The usual movement of the activity caused the remaining wires to break and the Centipede to fall.

Photos from broken centipede.
